November 10, 2025

Re: Gallon Measure (Bernard & Brian Calabro)
3106 Albany Post Road
Buchanan, New York

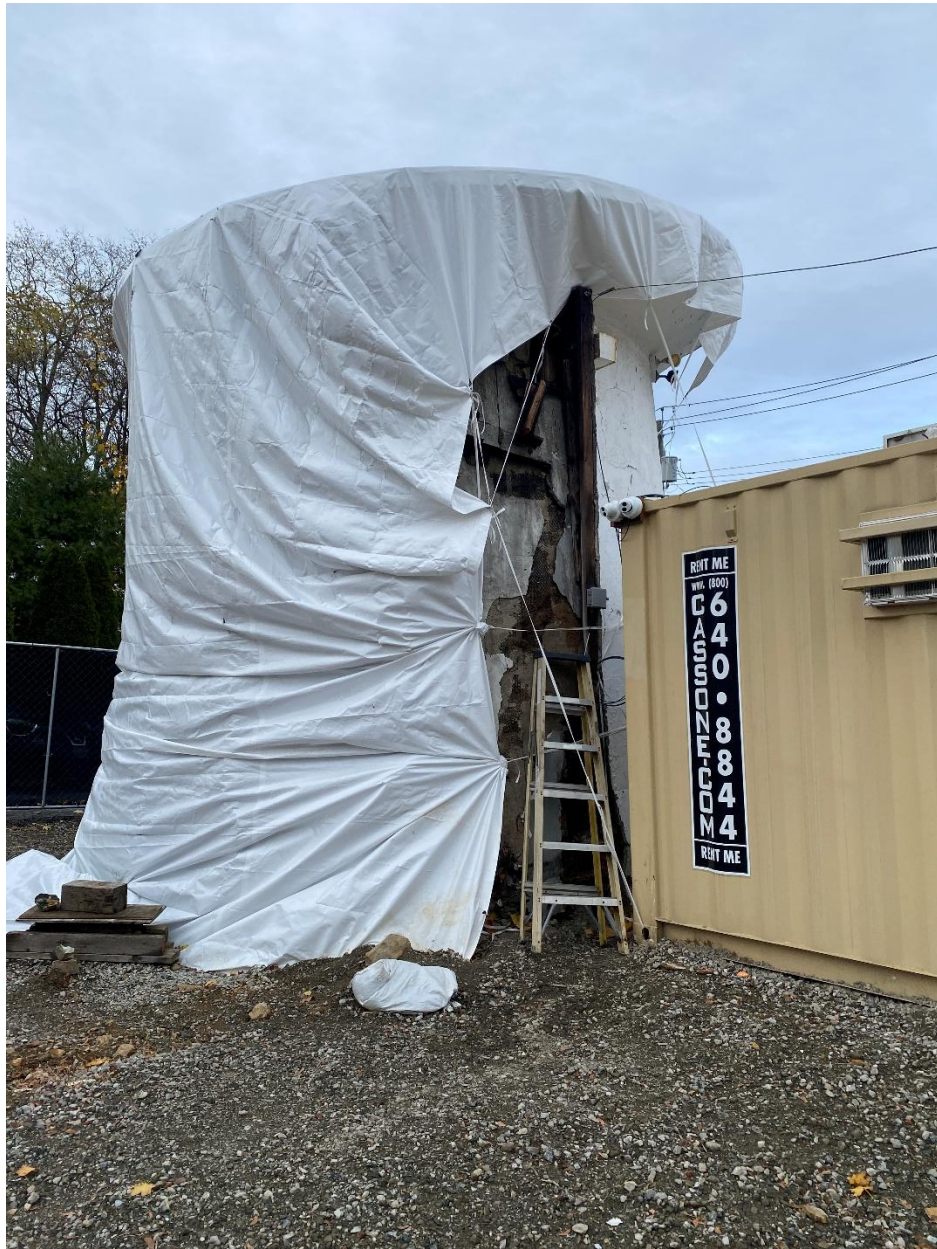
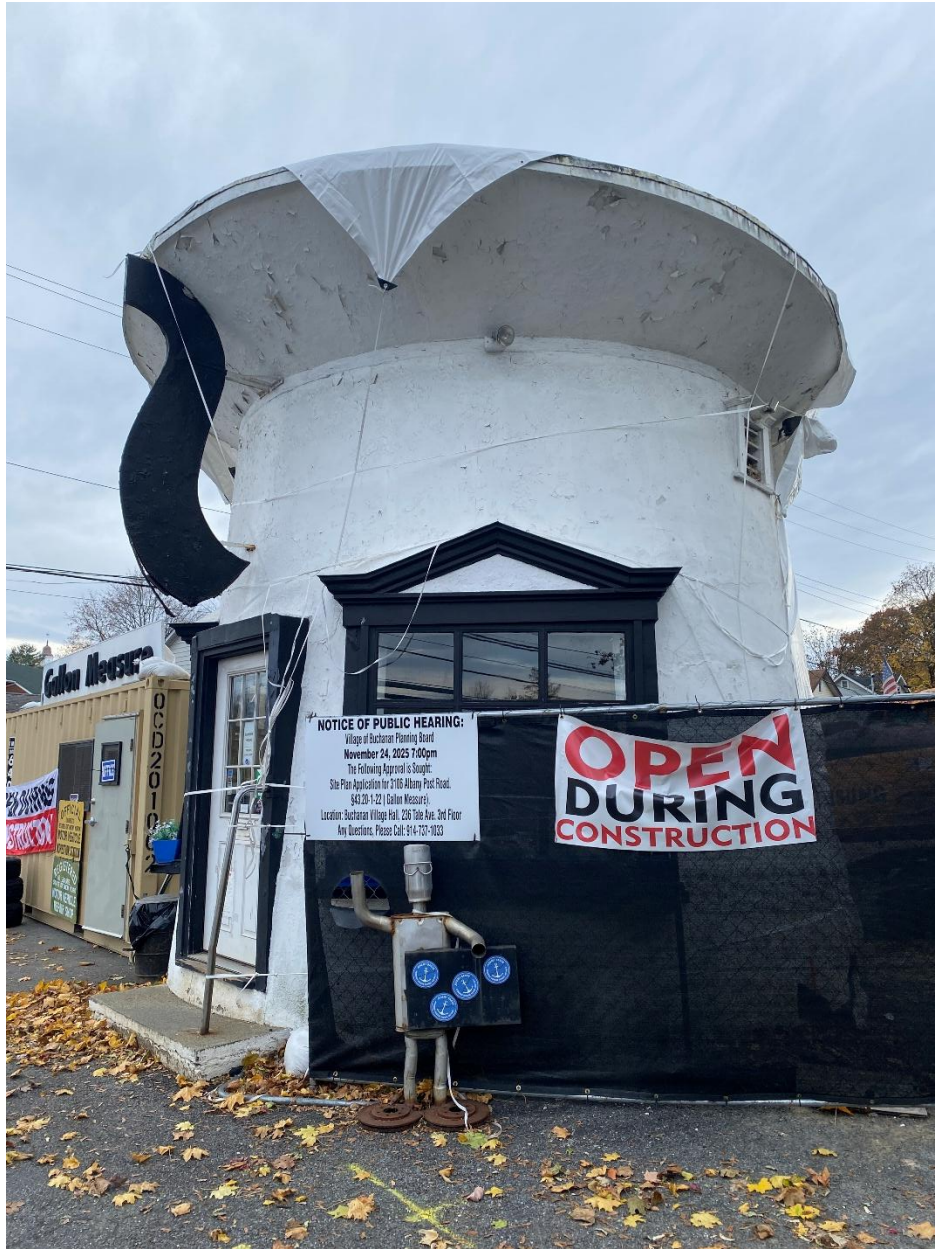
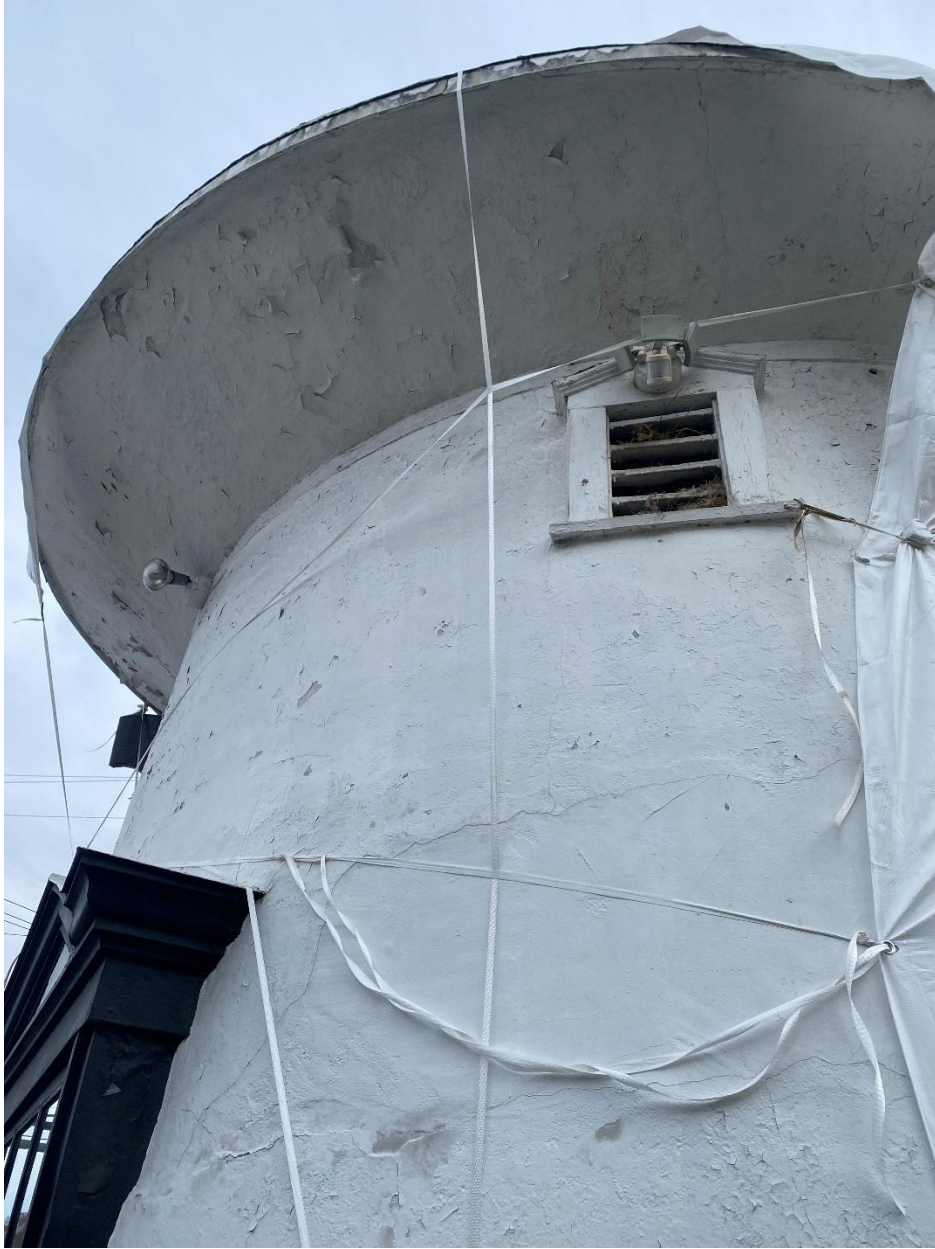
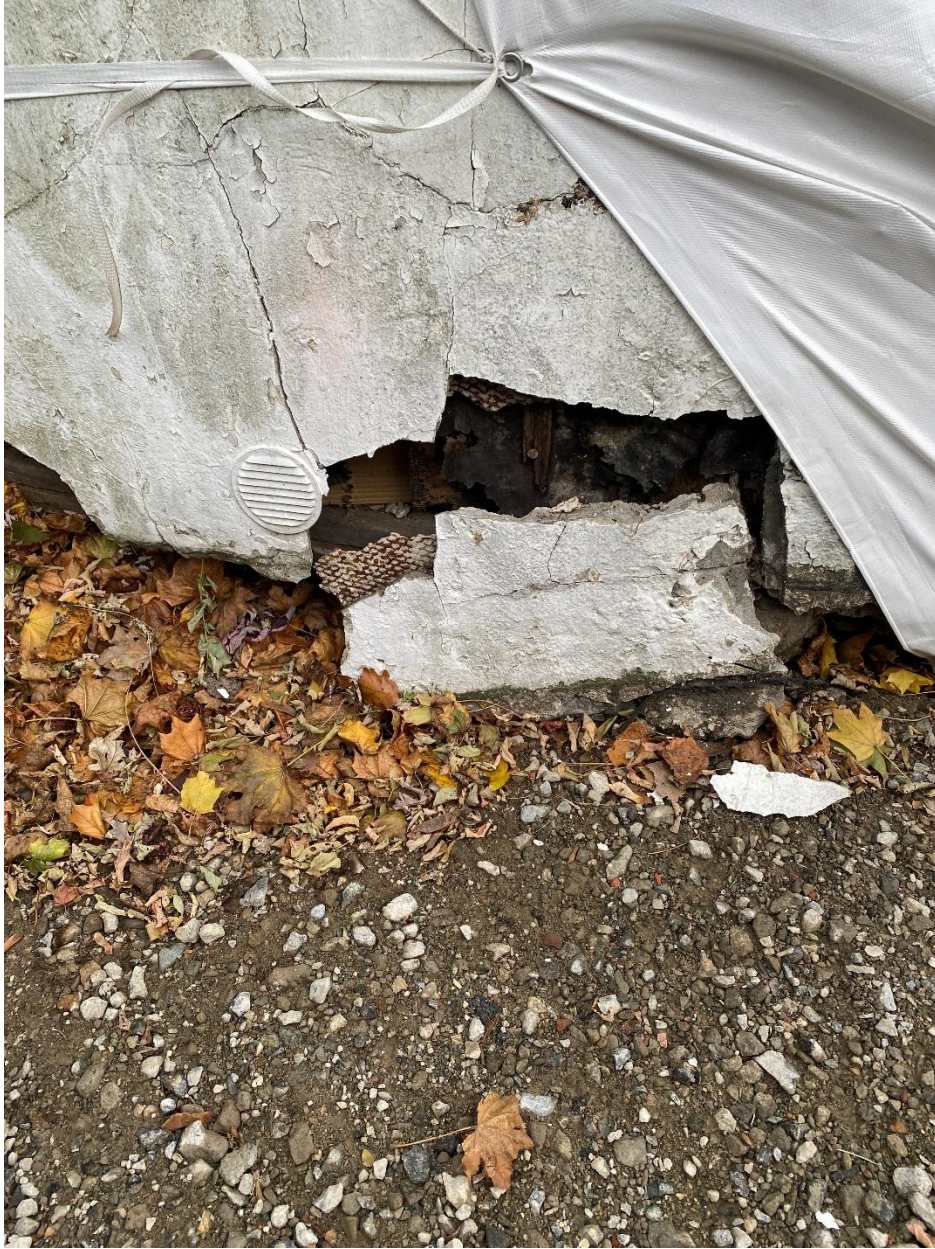
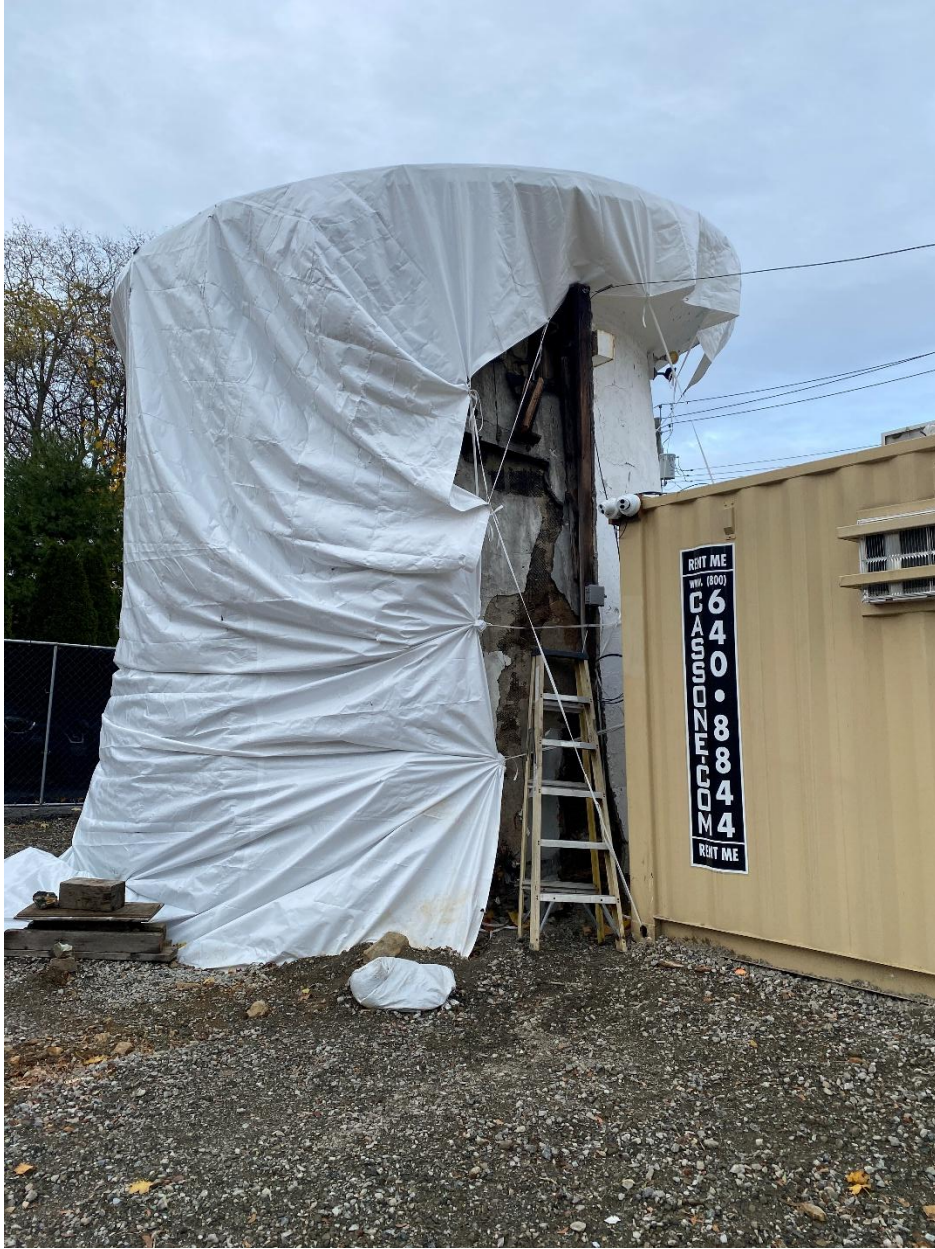
The structure is resting on a crawl space and a concrete foundation. The structure consists of a wooden frame onto which wire lathe and plaster have been placed to form the shape of the jug. Refer to the photographs attached to this letter. I am not sure the age of the structure. There are many stress cracks in the finished plaster surface of the structure.

The wood framing is not in good condition due to its age and exposure to moisture. The framing is not well connected to the base and is showing signs of deterioration. The plaster is also not in good condition. The wire lathe in some areas is exposed and corroded. There are areas where the plaster has dislodged from the wire lathe. This reduces the ability of the plaster to resist shear forces acting on the structure.

In summary, it is my opinion that the internal wooden structure along with the wire lathe and plaster finishes are not in good condition and will not be able to survive lifting or relocating of the structure to another location.
